OV-1 ACCIDENT SUMMARY

1 July 1963 through 30 June 1966

Investigation and Engineering Division
Engineering Branch

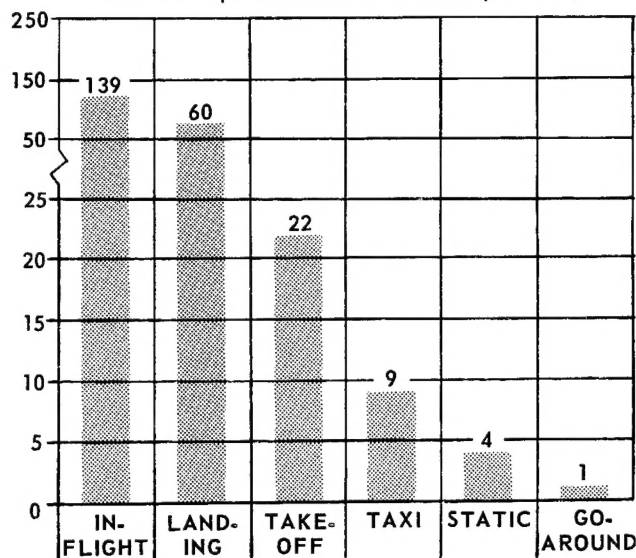
FIGURE 1
Phase of Operation in Which Mishap Started

VIII. PHASE OF OPERATION: Figure 1 shows the phases of operations in which mishaps started. The inflight phase accounted for 59% of all mishaps and the landing phase accounted for 25%. The majority of mishaps were caused by materiel failures or malfunctions.

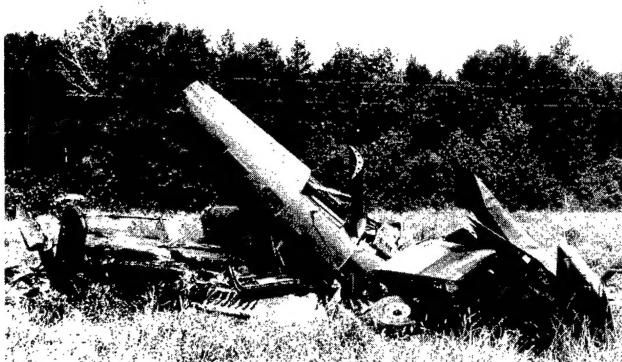
08113

08113—Aircraft struck two 3/8" ground cables located above high tension electrical power lines. The wires broke and aircraft hit a 40-foot pine tree, coming to rest in the center of a pond, and scattering debris throughout the pond and 55 yards up the side of a hill. Caused by: 1. Aircraft flying into 3/8" steel ground cables. 2. Difficulty in detecting wires from low altitude. 3. Failure to indicate location of a known flight hazard on maps used during low level flight. 4. Lack of positive instructions on gunnery procedures to be used during combined arms training exercises. 5. Conducting instruction in low level gunnery techniques to a non-gunnery qualified pilot during a combined arms training exercise.

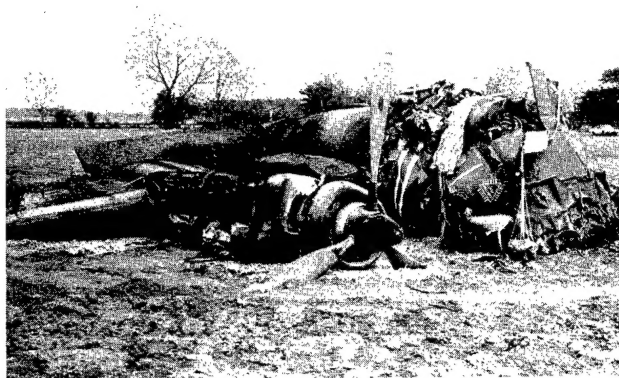
C664

C664—Aircraft departed airfield and was climbing through 4,200 feet when the No. 1 engine caught fire. Fire could not be extinguished with internal fire bottles. Both the instructor pilot and pilot made a safe ejection at 1,600 feet and received only minor injuries. The primary cause of this accident was a fire in the area of the No. 1 engine caused by misalignment of the dowel pin located in the No. 4 bearing pump housing and retainer ring, causing pressurization of the No. 3 and 4 bearing package. Pressurization resulted from inability of the front pump located forward of No. 3 bearing to evacuate the additional oil. The oil was then forced between the carbon seal and the power turbine stub shaft seal journal. This resulted in the erosion of the carbon seal, loss of lubrication, and subsequent failure of the No. 3 and 4 bearings.

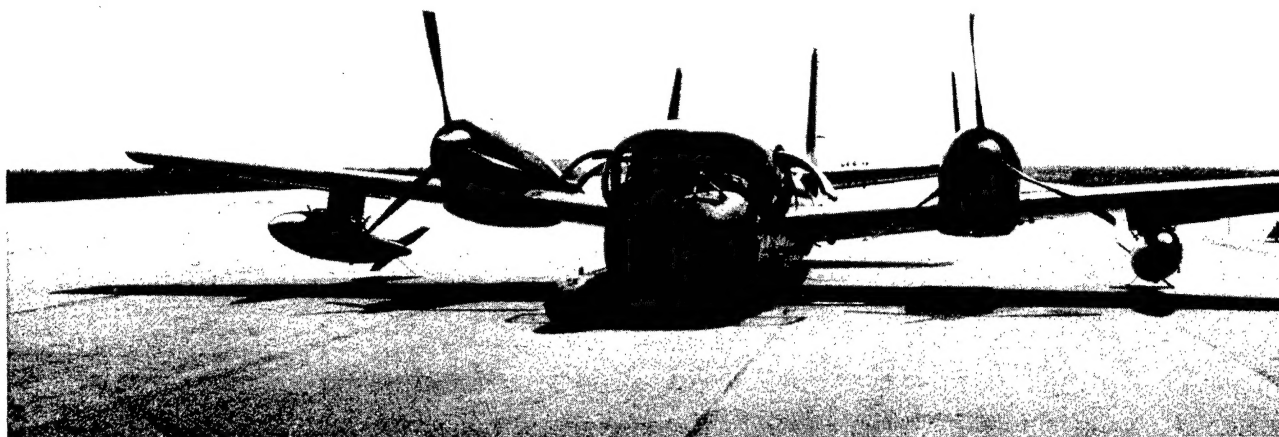
C122

C122—Aircraft was landed gear-up. Caused by failure to lower landing gear. Pilot did not use pre-landing checklist.

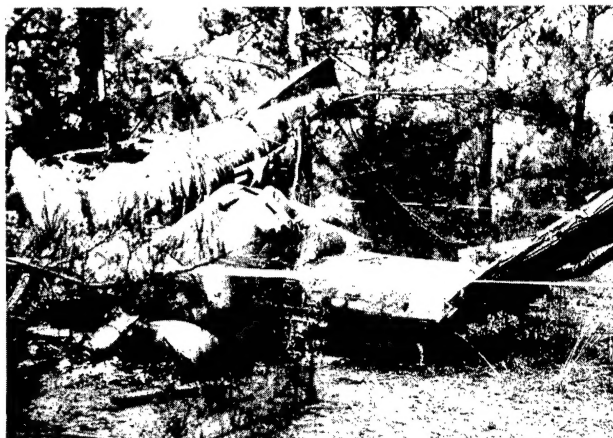
E103

E103—Aircraft was on an authorized night VFR training flight. Clearance had been obtained for a touch-and-go landing from an ILS approach. Landing was completed at approximately mid-field and power applied for takeoff. Aircraft became airborne about three-quarters of the distance down the runway. Aircraft veered to the right 45° from the takeoff heading, traveled a distance of 1,500 feet, crashed and burst into flames. Both occupants received fatal injuries. Probable cause of the accident was inadvertent feathering of the No. 2 engine propeller on takeoff. Contributing factors were: 1. Inability of the flight crew to cope with an emergency that was self-induced. 2. Lack of standardization of instructor pilot. 3. Touch-and-go landings at night.
